Surface quality varies with headrig chipping

by G. E. Woodson and S. M. Rigby

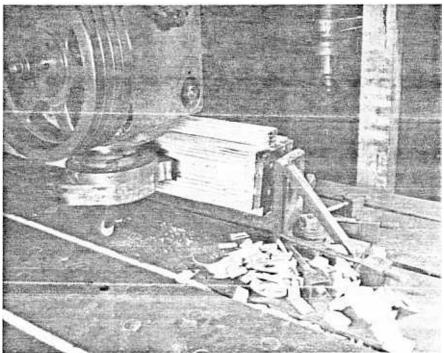
Fig. 1. Chipping with planing action

and arrangements to remove chips by either planing action or end-milling. See figures 1 and 2 for illustrations.
